THE RUNAWAY DIESEL - A SIDE BY SIDE MECHANICAL ANALYSIS

Christopher W. Ferrone
Triodyne Inc.

Charles Sinkovits
Triodyne Inc.

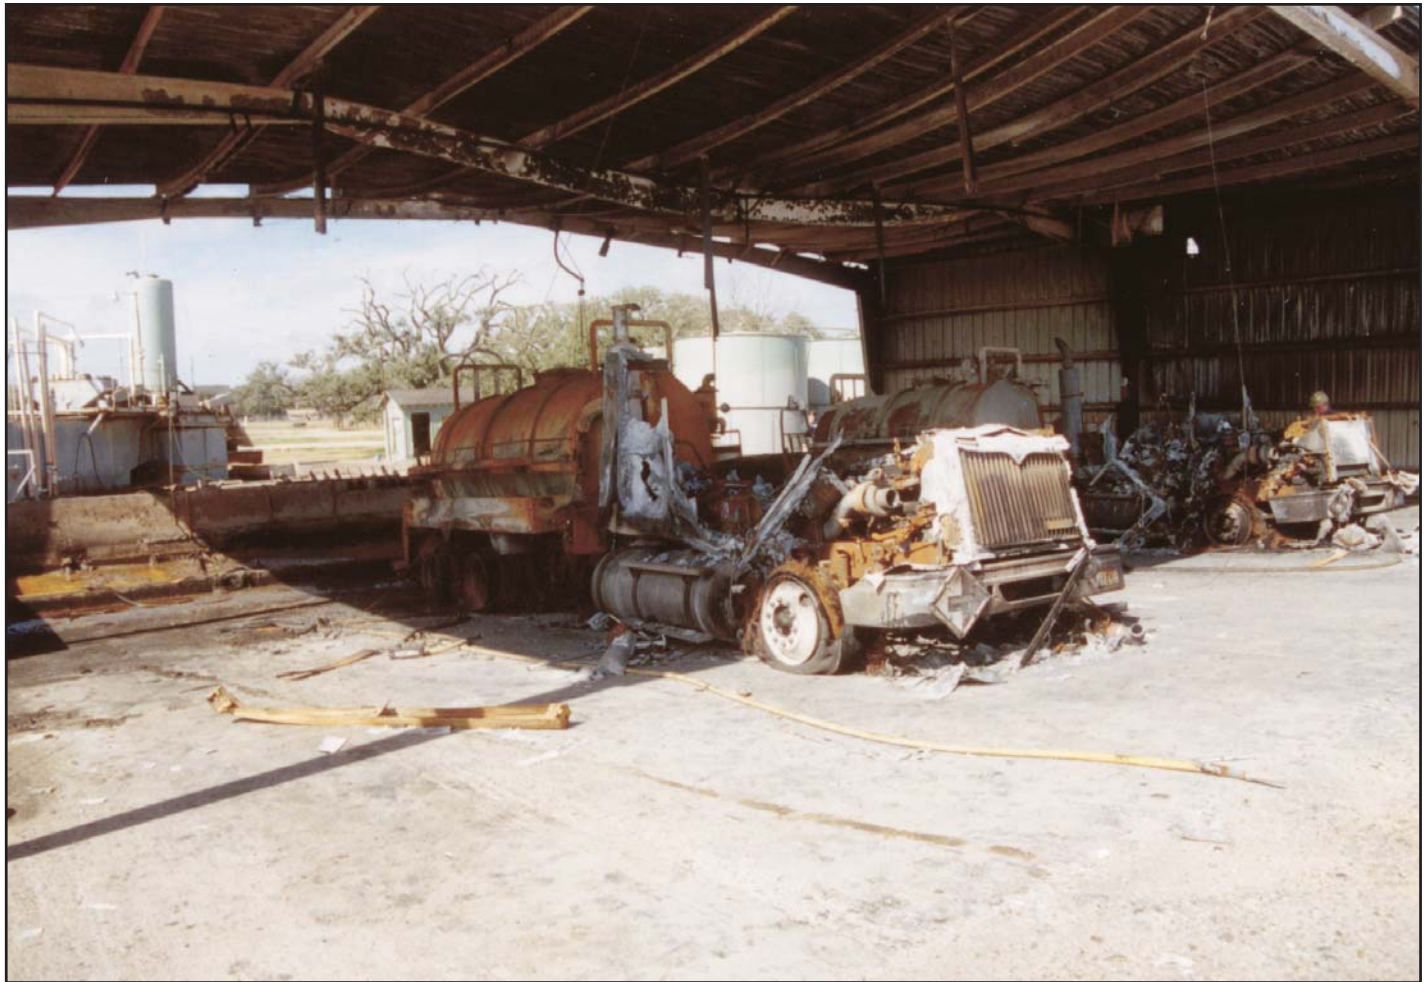
flammable vapor cloud formed in the unloading area. Vapor was drawn into the air intakes of the trucks' running diesel engines causing them to overspeed, backfire, and ignite the flammable cloud (Photo 1). Two BLSR employees standing near the trucks were killed in the fire and three others suffered serious burns. The two drivers, who were employed by T&L Environmental Services Inc., were also burned after rushing back to their trucks when they heard the engines accelerate. One of the drivers died several weeks later from his injuries [1].

Photo 1 - Accident Scene (Two Trucks)

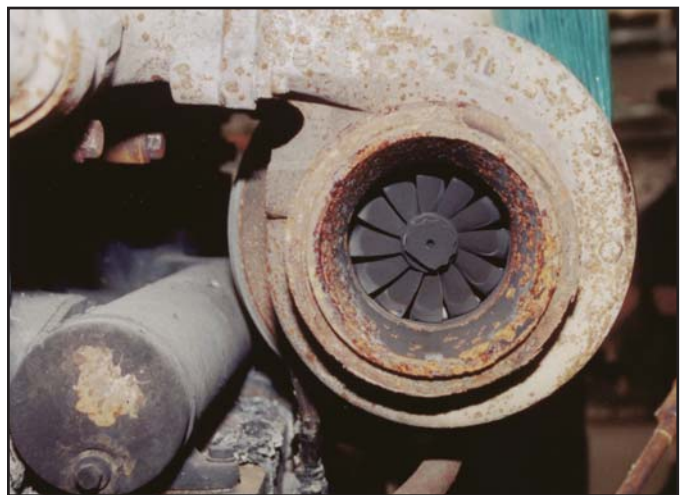
When a diesel engine burns fuel, it leaves a distinct combustion pattern. The internal components – exhaust valves, exhaust manifold and turbocharger impeller (Photo 2) – are coated with soot and piston firing surfaces are usually coated with a dark colored mixture of oil, diesel fuel and soot which ultimately leads to a black coating (Photo 3).

**Photo 2 - Turbocharger Impeller
(North Engine) Soot Covered**

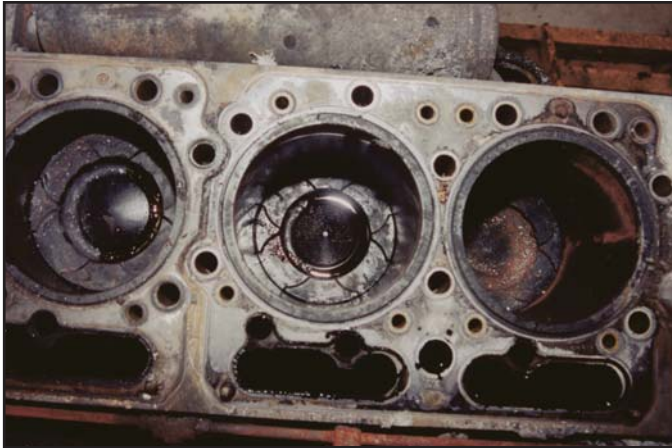
**Photo 3 - Piston Firing Surfaces (North Engine)
Diesel Fuel / Soot Covered**

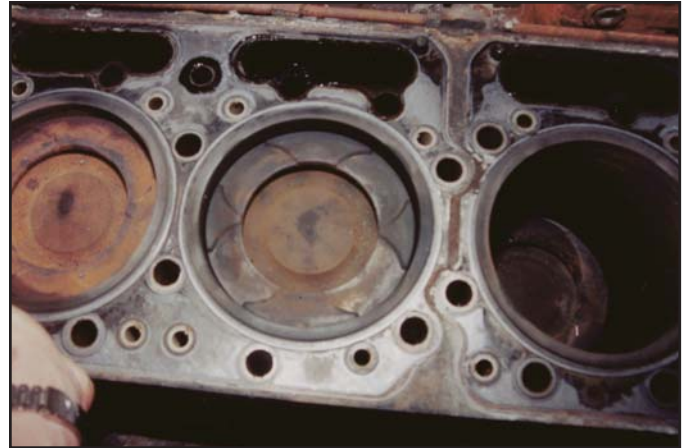
When a diesel engine ingests an *external fuel source*, the appearance of the internal components changes. The exhaust valves, exhaust manifold, turbocharger impeller and pistons become “cleaned” (Photo 4a, 4b) as a result of the subsequent “scrubbing” action and elevated temperatures which are noted by the blue appearance of the turbocharger bearings, etc. . . . (Photo 5).

**Photo 4b - Piston Firing Surfaces (South Engine)
Scrubbed Clean**

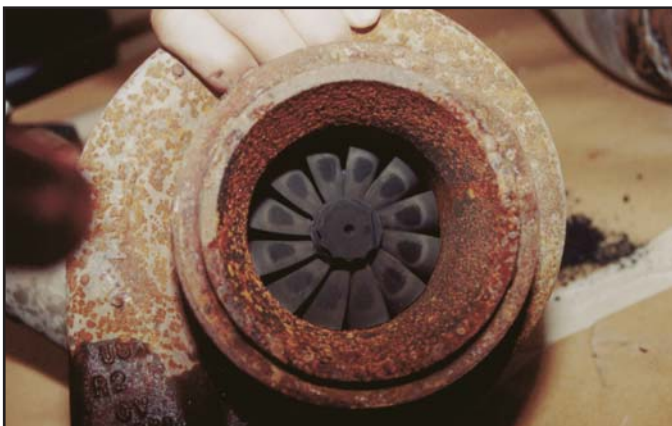
**Photo 4a - Turbocharger Impeller (South Engine)
Scrubbed Clean**

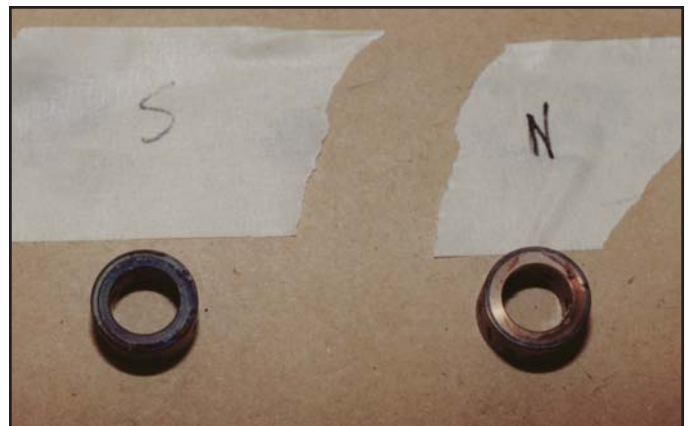
**Photo 5 - Turbocharger Bearings
(Left) Bluing (Right) Normal**

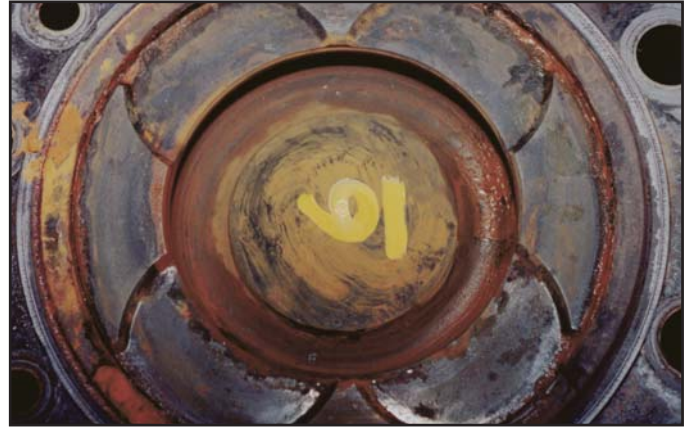
In this condition the valve train components (tappets or cam followers) lose contact with the cam lobes because the valve springs are not strong enough to overcome the momentum of the various valve train components at the overspeed RPM. The onset of valve float usually prevents higher RPM operation due to loss of compression. Extended periods of valve float will damage the valve train and subsequently put the valves in contact with piston firing surfaces (Fig. 2). This will occur at engine speeds greater than the no-load maximum. Additionally, cylinder head components, valve spring retainers and locks can become damaged (Fig. 3). Once this happens, push rods can fall down through the engine block and into the oil pan. Along the way, the push rods may become bent, showing additional evidence of overspeed. Photo 6 shows valve contact with a

Photo 6 - Piston Valve Contact (South Engine)

piston on the South engine; photo 7 shows no contact with the piston on the North engine. Photograph 8 illustrates damaged valve components for the South engine; photo 9 shows no damage on the North engine.

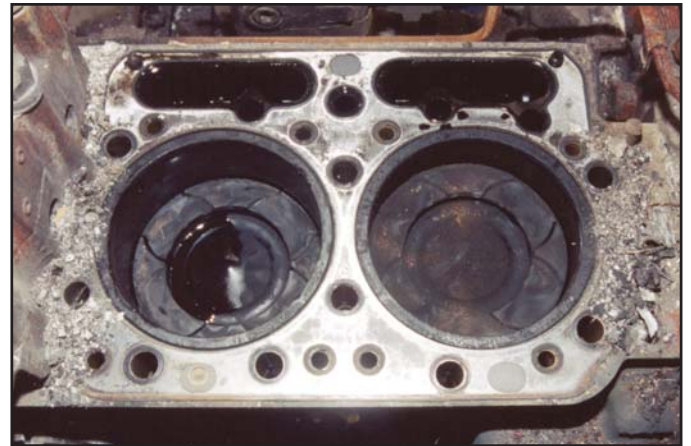
Photo 7 - No Piston / Valve Contact (North Engine)

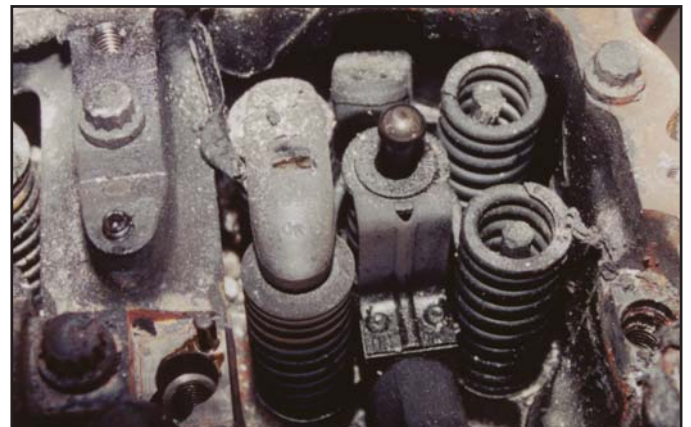
Photo 8 - Damaged Valve Components (South Engine)

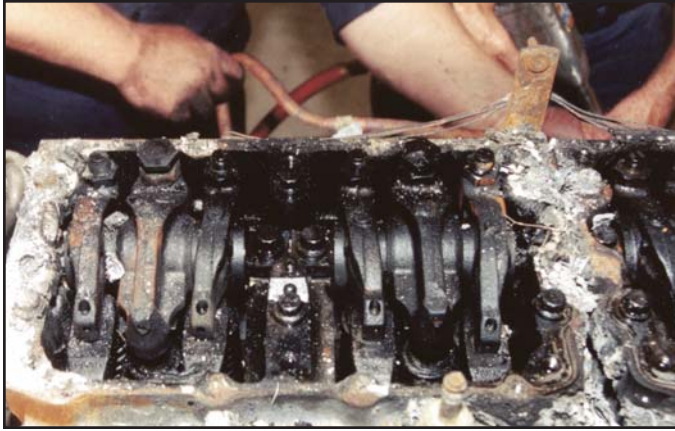
Photo 9 - Normal Valve Condition (North Engine)

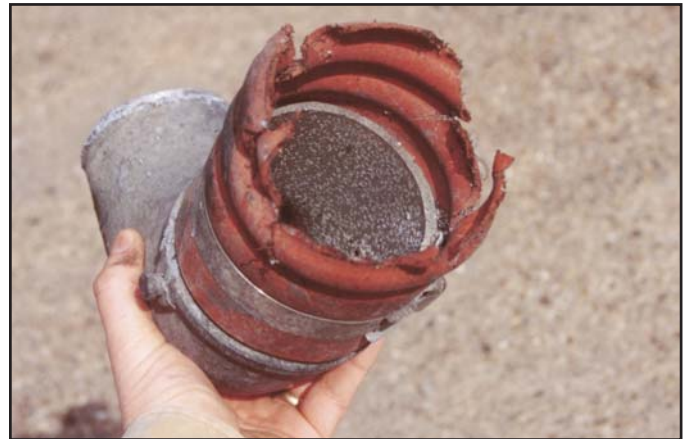
A destructive backfire is evidenced by a damaged turbocharger outlet elbow. Typically, the part is broken off of the turbocharger and “blown” clear of the main fire area (Photo 10). Damage to the 90° elbow and rubber hose (Fig. 6) is indicative of an explosion, not fire damage or heat. Photographs 11a and 11b show the South engine turbocharger with an explosion-induced broken elbow and rubber hose whereas photo 12 shows an intact, albeit melted elbow on the North engine turbocharger.

Photo 11a - Turbocharger Outlet Rubber Hose Connection (South Engine) Mechanical Failure

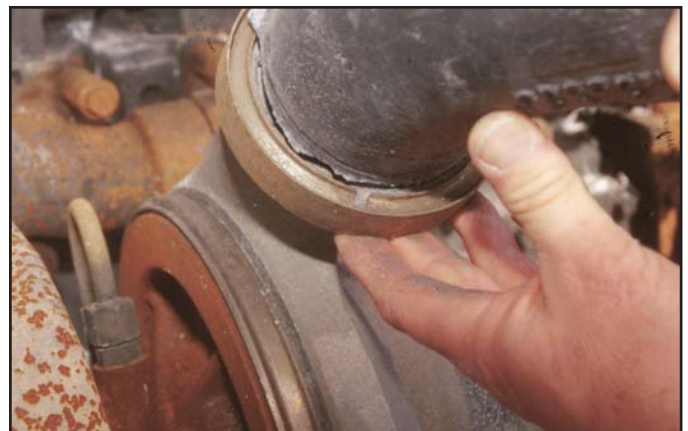
Photo 11b - Turbocharger Outlet Elbow (South Engine) Mechanical Failure

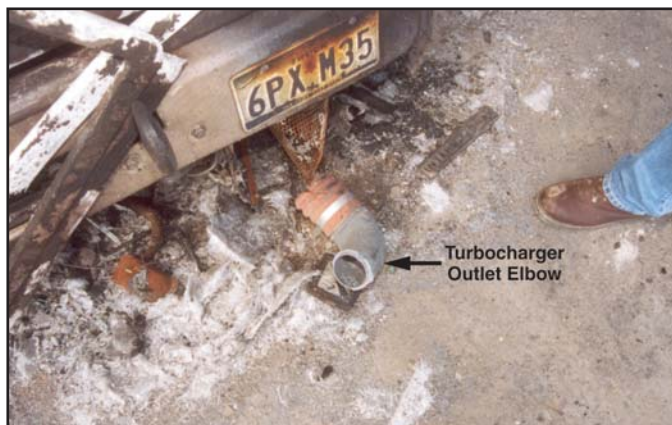
Photo 10 - Turbocharger Outlet Elbow (South Engine)

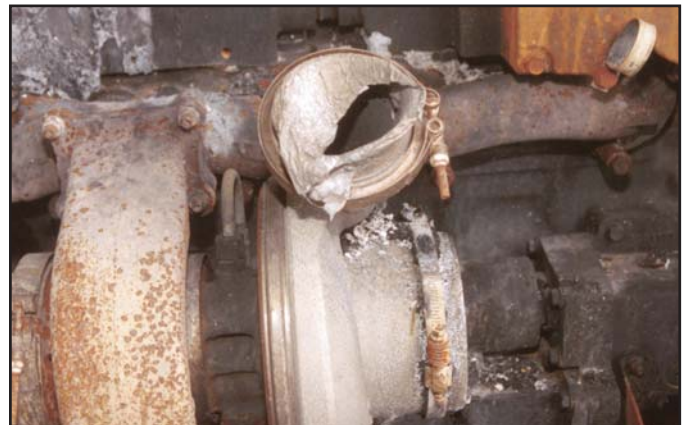
Photo 12 - Fire Damaged Turbocharger Outlet Elbow (North Engine)
