THE RUNAWAY DIESEL - A SIDE BY SIDE MECHANICAL ANALYSIS

Christopher W. Ferrone
Triodyne Inc.

Charles Sinkovits
Triodyne Inc.

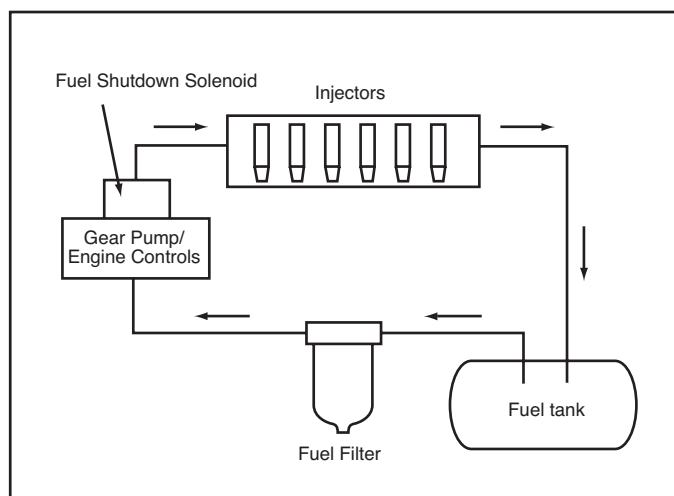
Figure 1 - Typical Diesel Engine Fuel System Schematic

When a diesel engine is exposed to an external fuel source such as an airborne combustible hydrocarbon in the surrounding environment, it naturally ingests the mixture into the air intake system. Since diesel engines control fuel and not air, the engine can no longer maintain speed control (Fig. 1).

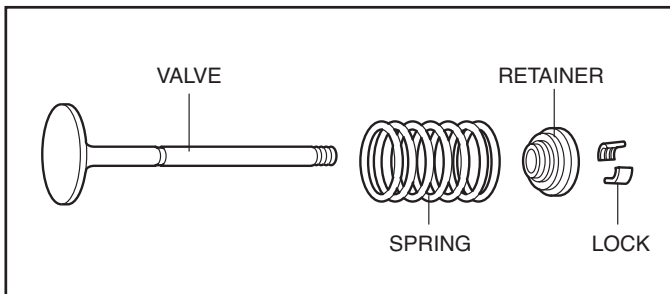
Figure 3 - Typical Valve Assembly

In this condition the valve train components (tappets or cam followers) lose contact with the cam lobes because the valve springs are not strong enough to overcome the momentum of the various valve train components at the overspeed RPM. The onset of valve float usually prevents higher RPM operation due to loss of compression. Extended periods of valve float will damage the valve train and subsequently put the valves in contact with piston firing surfaces (Fig. 2). This will occur at engine speeds greater than the no-load maximum. Additionally, cylinder head components, valve spring retainers and locks can become damaged (Fig. 3). Once this happens, push rods can fall down through the engine block and into the oil pan. Along the way, the push rods may become bent, showing additional evidence of overspeed. Photo 6 shows valve contact with a

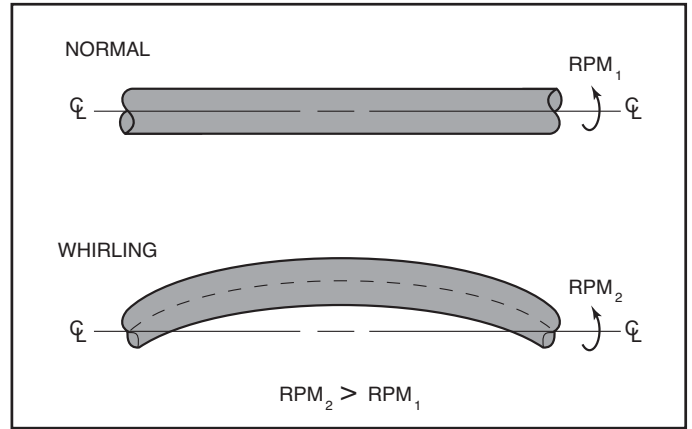
Figure 4 - P.T.O. Shaft Behavior

Another possible mechanical signature left behind after an overspeed incident is a bent power-take-off shaft (P.T.O.). The P.T.O. is typically used to drive a pump to off-load a product from a truck or trailer. If engaged during the overspeed excursion, the P.T.O. can behave in a manner known as whirling. This is a physical phenomenon that actually bows the shaft once it achieves a certain rotational speed beyond its design speed (Fig. 4). Whirling is defined as the rotation of the plane made by the bent shaft and the line of centers of the bearings [4]. This signature can be used to further determine if an overspeed has occurred.

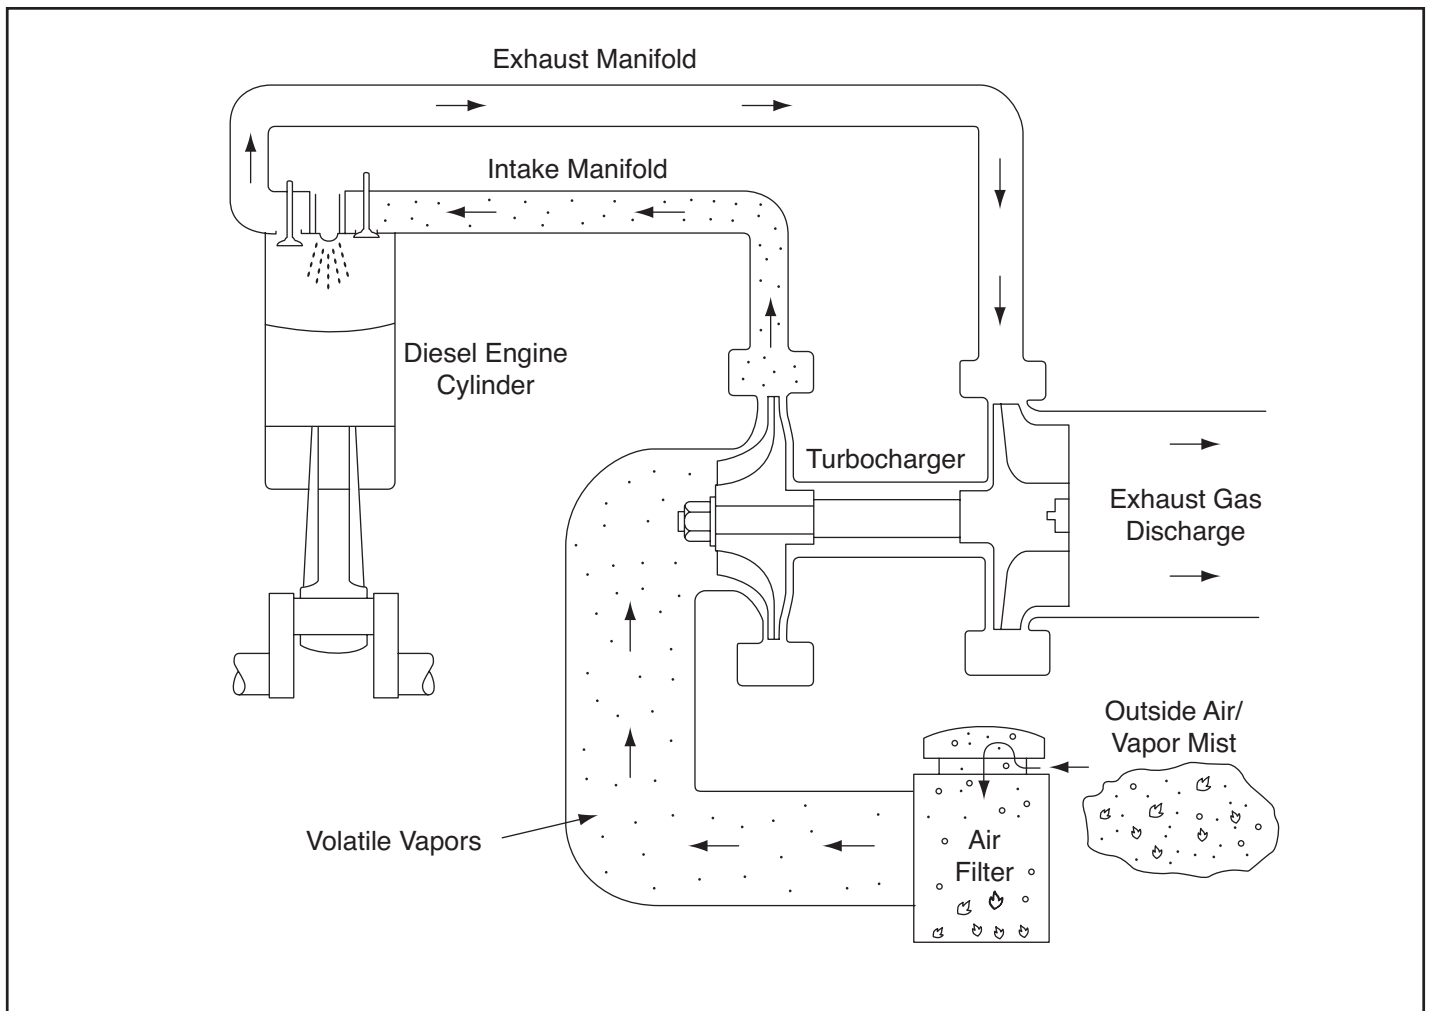
Figure 5 - Typical Air Intake System - 4 Cycle System

If the engine has ingested enough external combustibles and runaway, the probability of fire dramatically increases. As the engine instability increases in magnitude, the likelihood of a “destructive backfire” increases. Specifically, the intake ducting and manifold fill with combustibles (Fig. 5) and due to

valve float, the combustion process is now open to the intake system, igniting the volatile mixture and creating a fire that moves backwards through the intake.

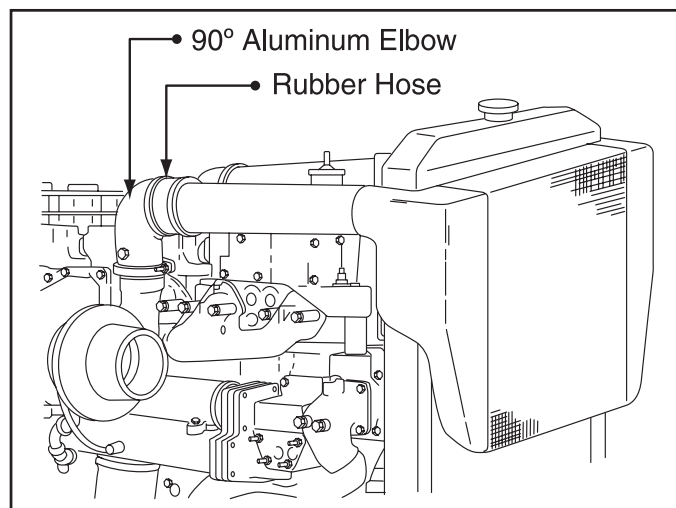
Figure 6 - Turbocharger to Aftercooler Connection

A destructive backfire is evidenced by a damaged turbocharger outlet elbow. Typically, the part is broken off of the turbocharger and “blown” clear of the main fire area (Photo 10). Damage to the 90° elbow and rubber hose (Fig. 6) is indicative of an explosion, not fire damage or heat. Photographs 11a and 11b show the South engine turbocharger with an explosion-induced broken elbow and rubber hose whereas photo 12 shows an intact, albeit melted elbow on the North engine turbocharger.

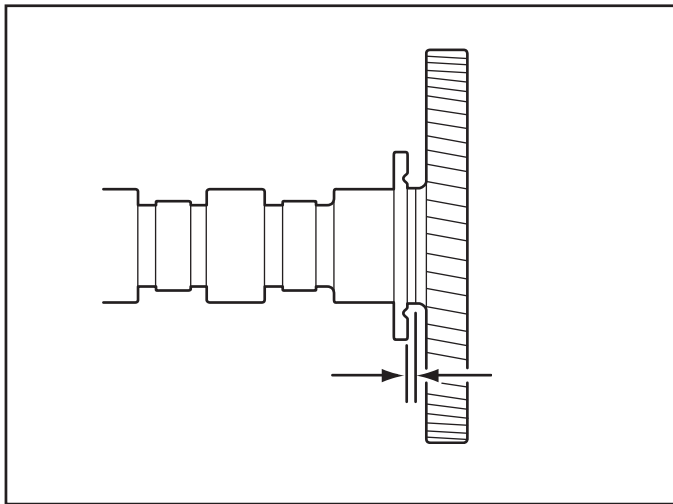
Figure 7 - Cam and Gear “Walk Off” Clearance

- Worn/broken valve collets
- Cam gear walk-off (Fig. 7)
- Larger valve lash than specified within the engine repair manual
- Valve collet wear markings below the prescribed collet groove (Fig. 8)
- Small cracks on the underside of the valve spring retainers (Fig. 9)
- Loose vibration damper/bolt hole fretting
- Loose flywheel/broken cap screws/bolt hole fretting
- Cam lobe stress marks
- Cam follower(s)/tappets - excessive wear
